# Manhole Inspection Summary

Manhole # S39WW\_054MH

Insp Date: **12/18/06 12:07 PM**

**Location** Address: **820 HOMESTEAD ST**

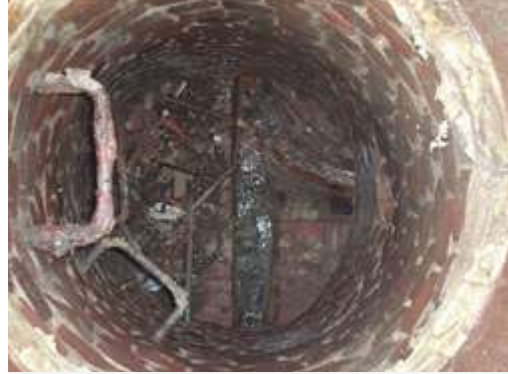
Top View

Corroded steps. Evidence of surcharge - Bench and Channel debris.

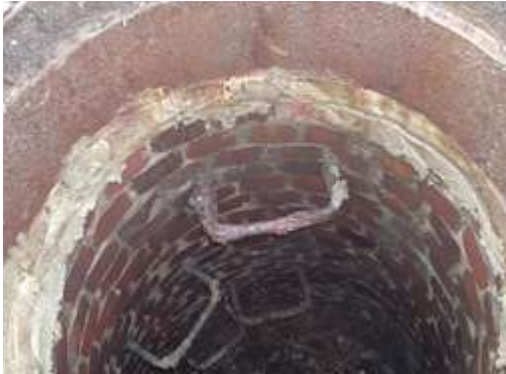
Defect

Frame leaks. Adjustment and Barrel infiltration.

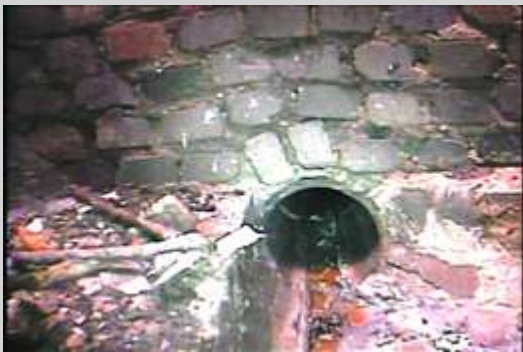
### 8 in. Circular Gravity Sewer Pipe Out @ 12 O'Clock

Barrel deterioration and infiltration. Channel deterioration.

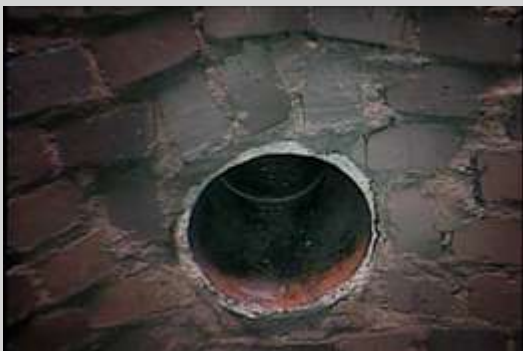
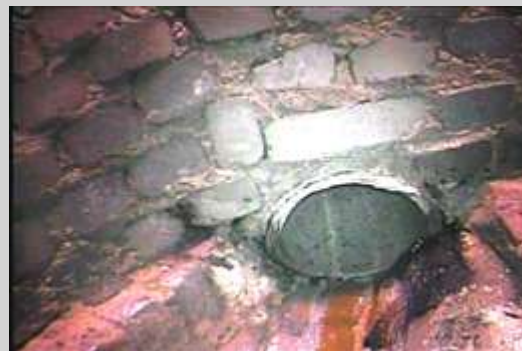
### 8 in. Circular Gravity Sewer Pipe In @ 3 O'Clock

Barrel deterioration and infiltration.

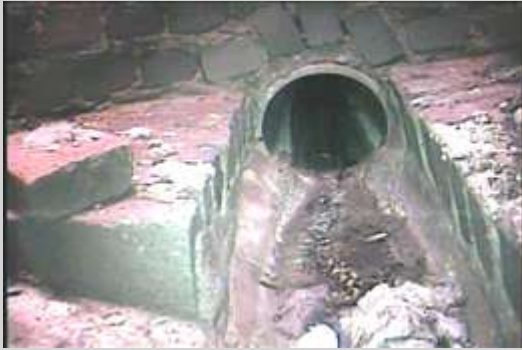
Pipe In @ 6 O'Clock

Channel debris.
